To: Blake, Ellen[Blake.Ellen@epa.gov]
From: Rao, Kate
Sent: Tue 8/11/2015 6:44:55 PM
Subject: FW: Gold King Mine Spill - brief background and initial EPA Region 9 response (internal - do not release)

From: Rao, Kate
Sent: Tuesday, August 11, 2015 10:37 AM
Subject: Gold King Mine Spill - brief background and initial EPA Region 9 response (internal - do not release)

When our river turned orange

Nine things you need to know about the Animas River mine waste spill.

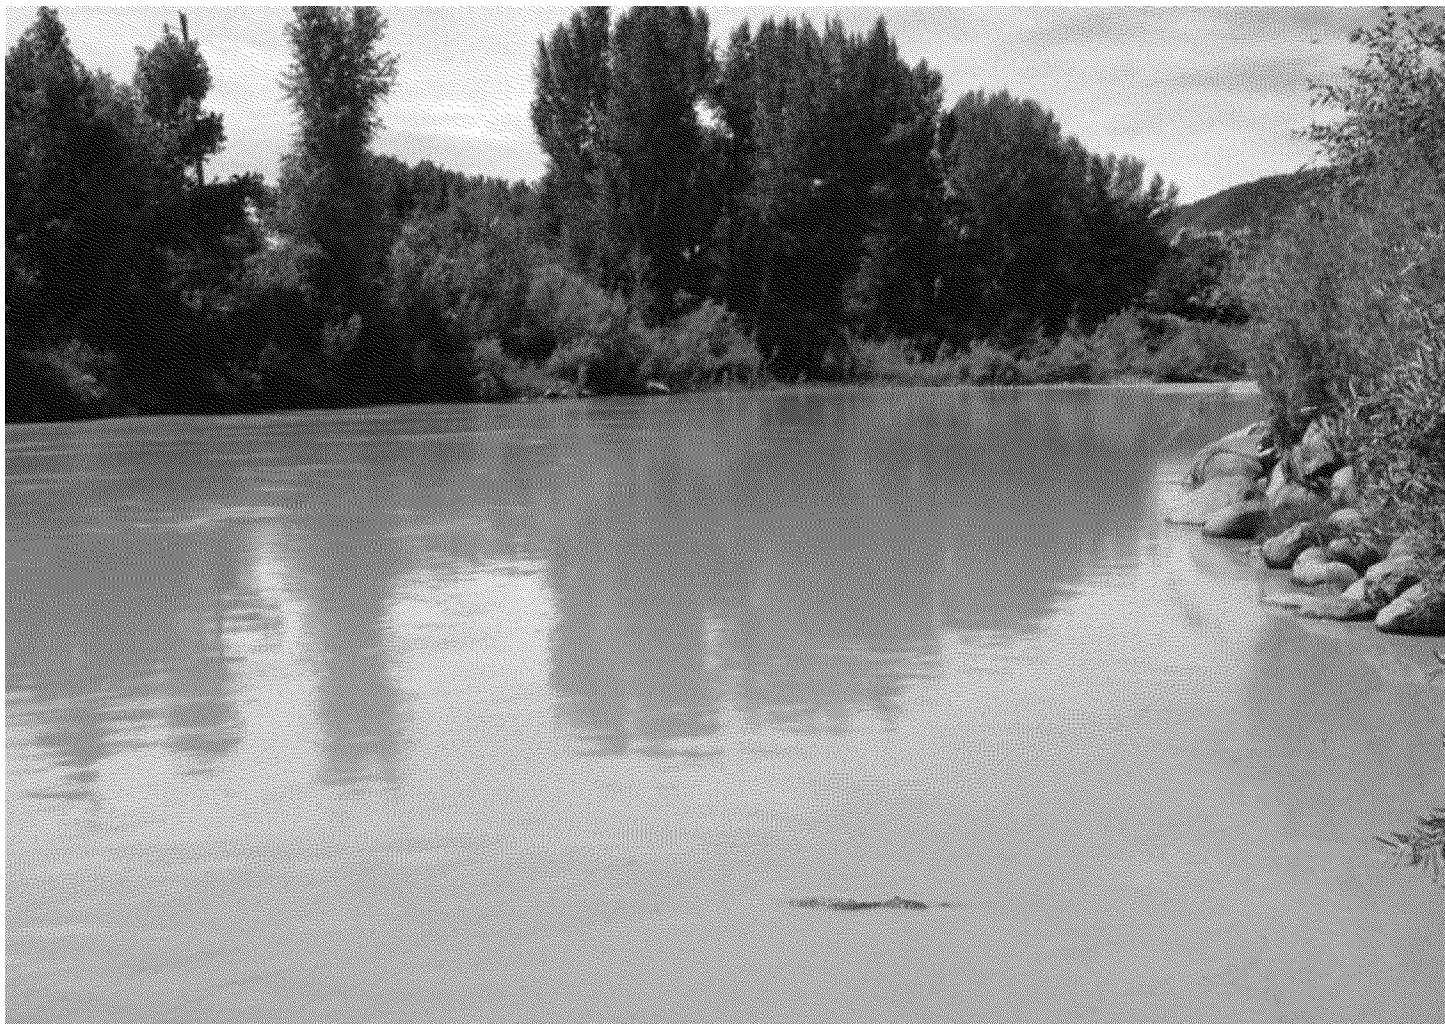
The river turned a mustard-Tang color as the wastewater moved through. This was taken about 24 hours after the spill.

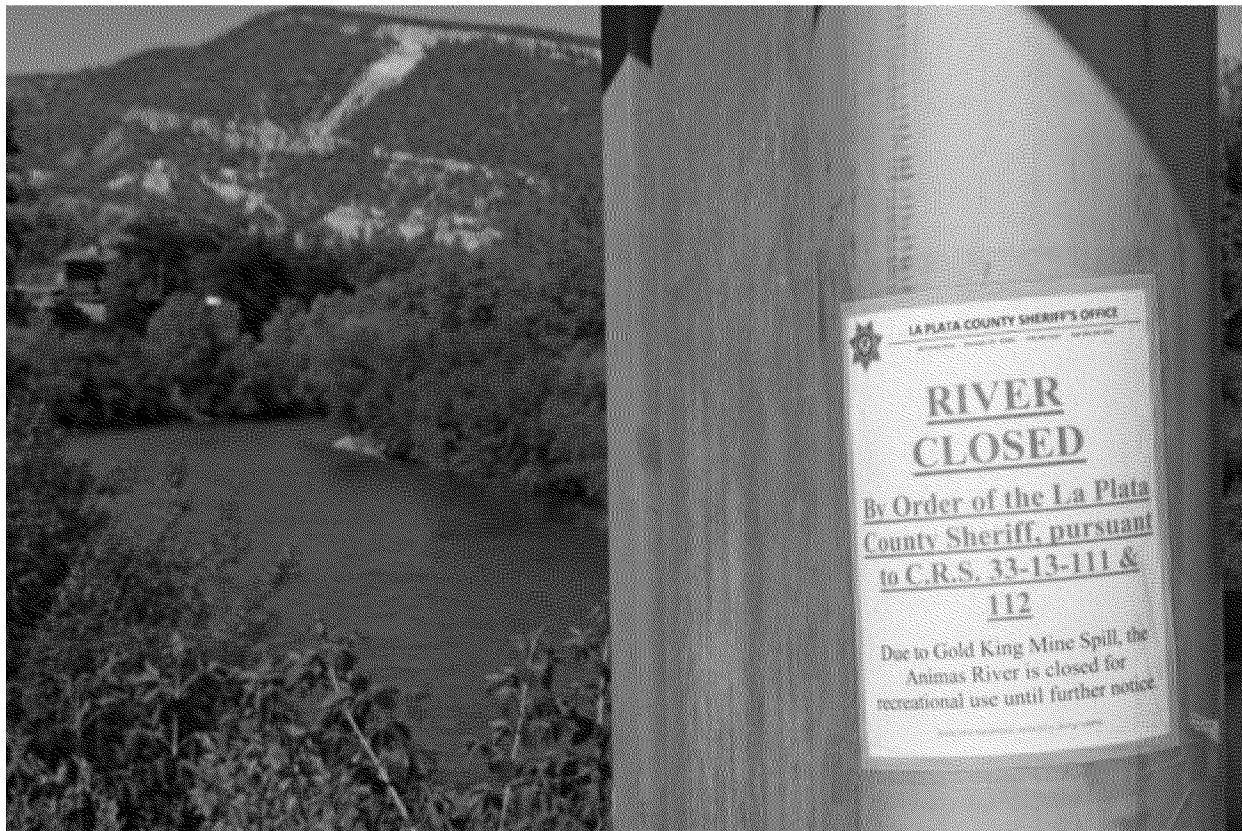
The Animas River was closed for public safety as the wastewater plume moved through town.

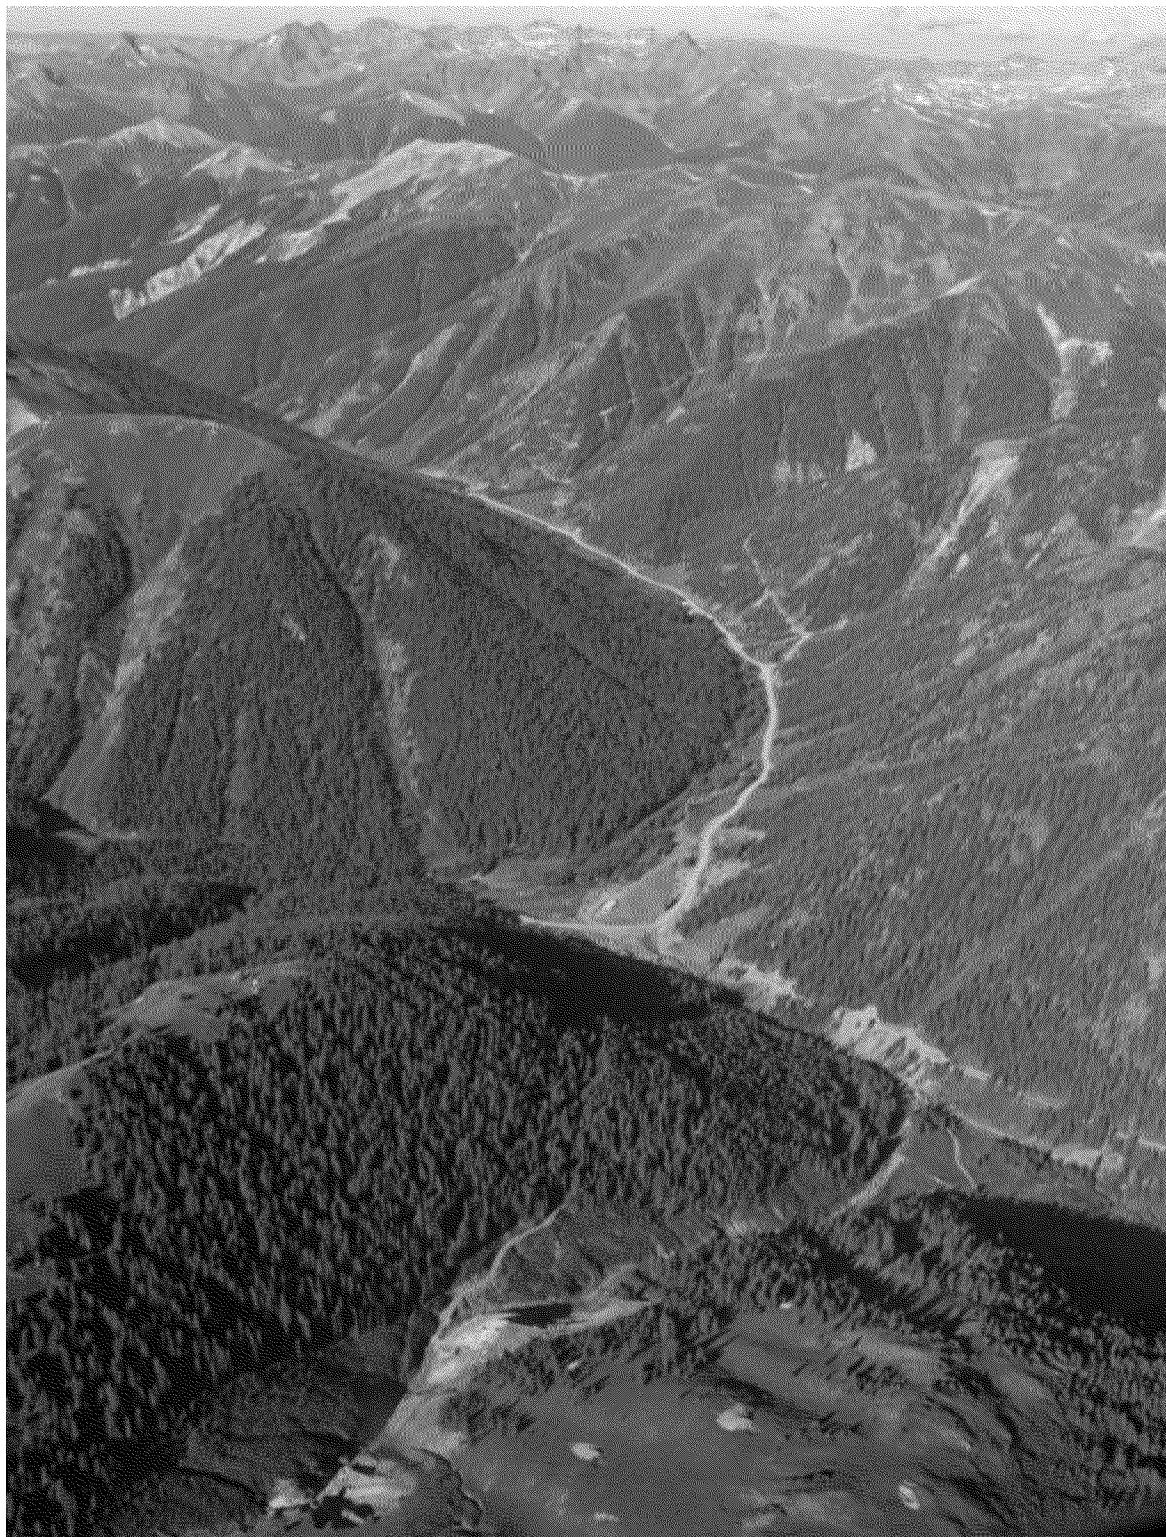
The Gold King Mine (bottom of picture) and Cement Creek. Cement Creek has probably never supported fish, and even before the spill had a pH level of about 3.5, on par with Coca-Cola.

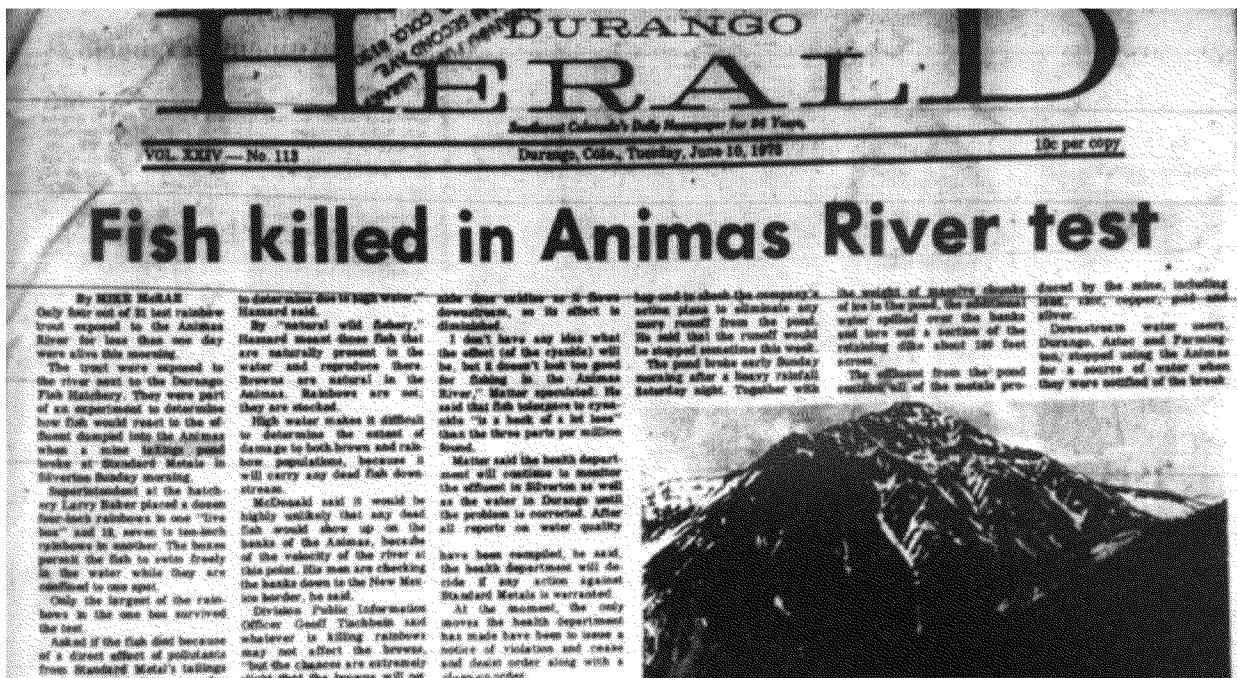
A 1975 tailings pile breach just above Silverton sullied the Animas River for 100 miles downstream, turning the water the color of "aluminum paint" and killing fish.

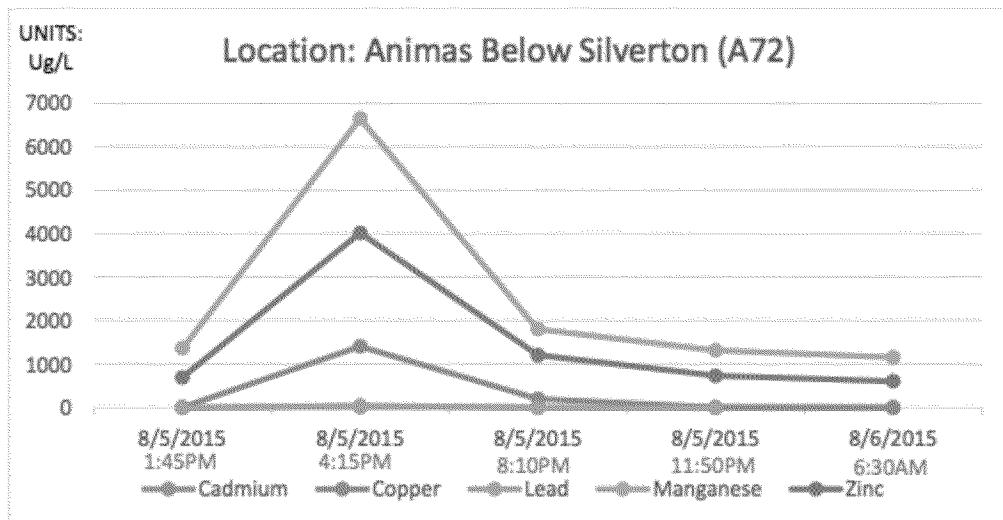
• **Short-term impacts aren't as bad as the water looks:** Sampling done by the [EPA](#) upstream from Durango show that the plume's peak put the Animas River's water's acidity on par with black coffee, and contained elevated levels of iron, manganese, zinc and copper. But by the time it reached town, the acidity had been diluted significantly, and levels of those metals were far lower, but still "scary," according to EPA officials. Still, the plume moved through quickly, lessening harm. A test by Colorado Parks and Wildlife, in which trout in cages were placed in the river prior to the plume's arrival, has so far shown no acute effects: Only one of 108 fish had died during the first 24 hours in contaminated water. Meanwhile, the [Mountain Studies Institute](#) has been monitoring macro-invertebrates, and their results have been similarly positive.

Samples taken by the EPA as the plume moved through show that it has high levels of heavy metals.

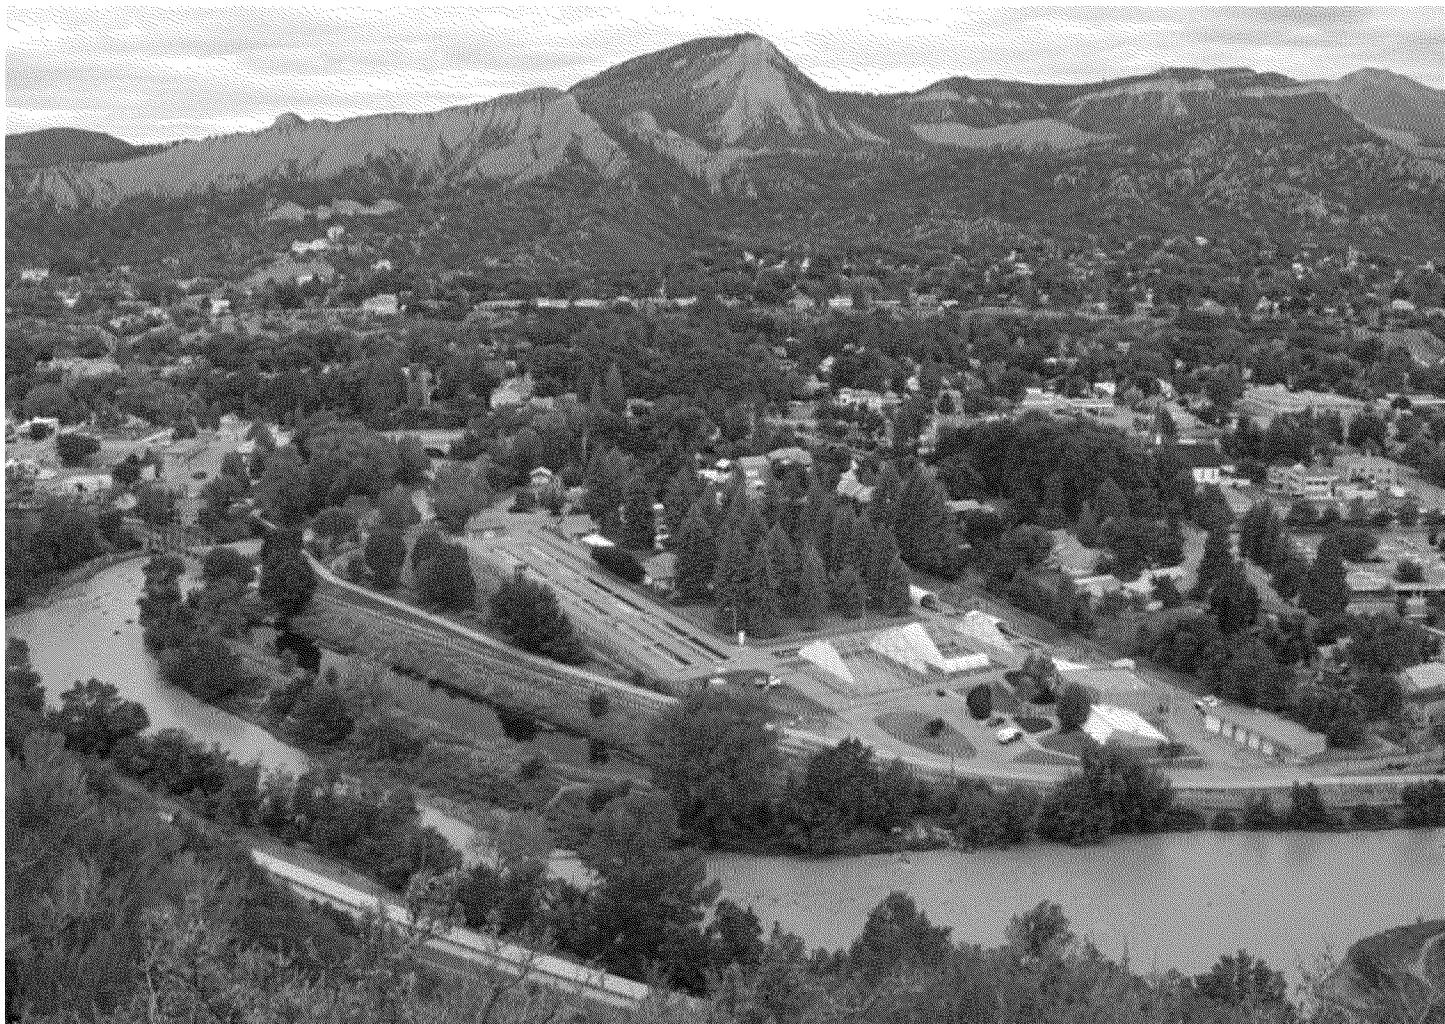
The contaminated Animas River as it runs through Durango. Note the contrast between the river and a fish hatchery pond next to it.
